PROMENTUM™

QUAD AMC CARRIER

SOFTWARE AND FIRMWARE UPGRADE INSTRUCTIONS

ATCA-1200

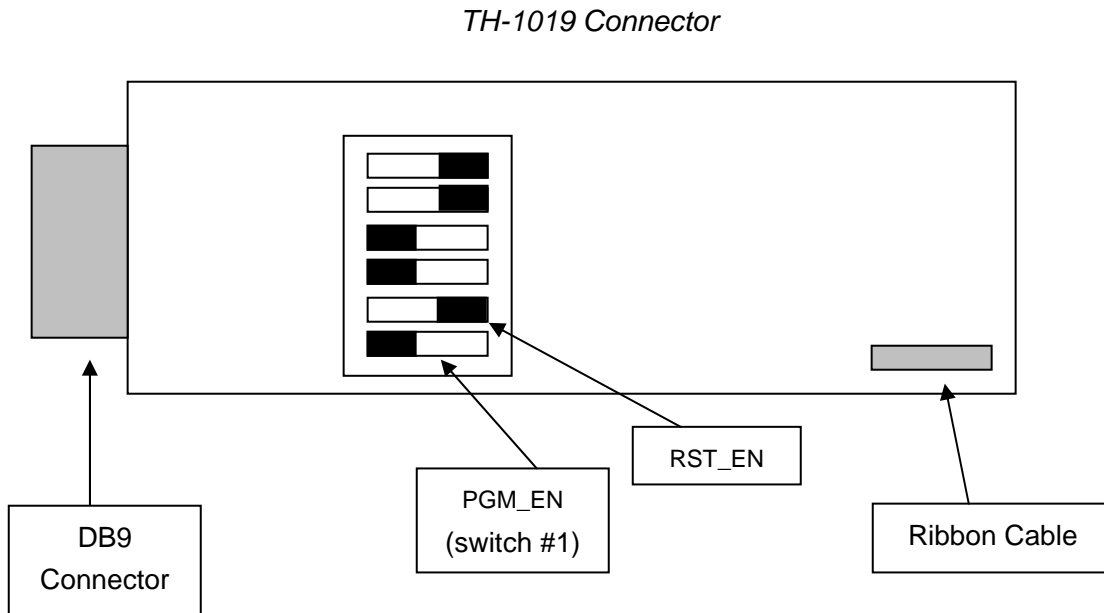
TH-1019 Connector Block Diagram

This is the setup required for flashing the IPMI firmware using Renesas Flash Development Toolkit (FDT). The PGM_EN switch is ON (move the switch towards the DB9-Connector as shown below).
